Setagaya City Registered
Tangible Cultural Property (Building)

Former Shimizu Residence Shoin

Visitor Guide

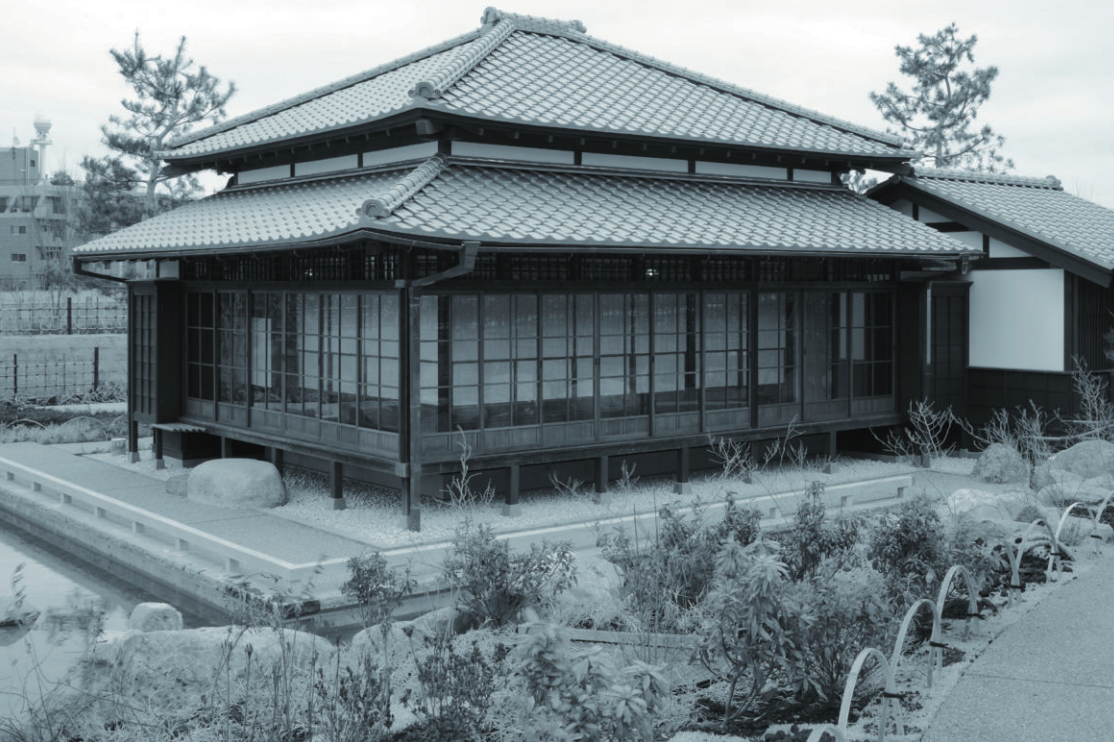
As seen restored and relocated in 2013 Photograph by Joe Shimizu

In 2013, the Former Shimizu Residence Shoin was finally moved and restored at Kishin-en, a Japanese-style garden at Futako-Tamagawa Park, thus breathing life into this example of modern Meiji-era Japanese architecture.

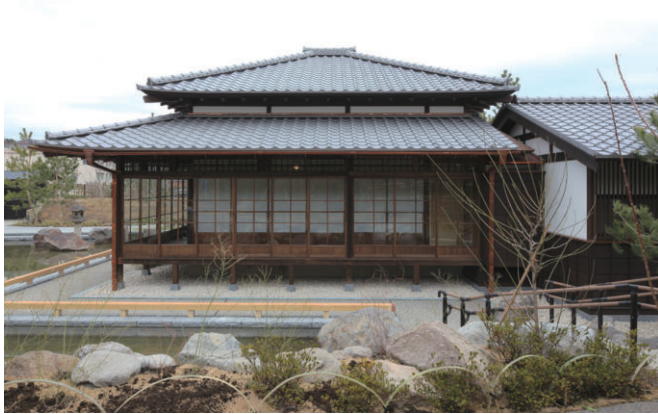
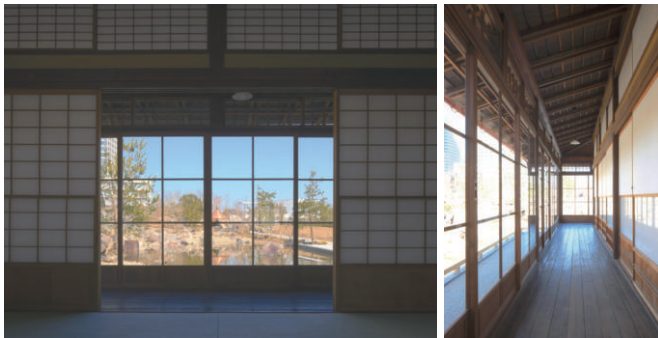
Of the Shoin's original materials, about 60% survived. Beams, roof frame, roofing tiles and other missing parts had to be replaced. Fortunately, much of the material from the interior remained, making it possible to restore it to its pre-demolition state.

The interior plan features a small scale layout with an 11 tatami-sized shoin and a 5-mat tsuginoma (additional room).

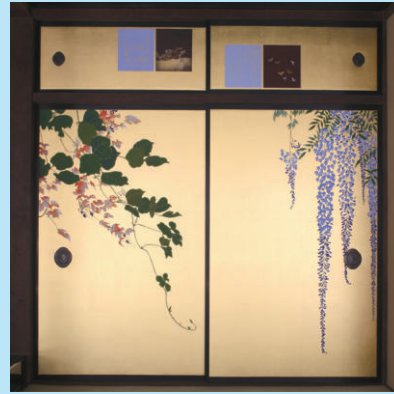
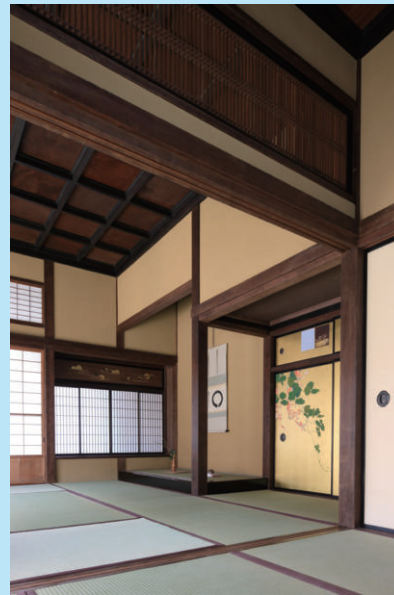
The hanging light fixtures from the center of the shoin (main room), also in the tsuginoma (additional room), were recreated from photographic references.

The latticework on the coffered ceiling of the shoin (main room) and the tokogamachi (the raised alcove on the bottom transverse trim) of the shoin as well as frame of the arching katoumado "fireplace window (named for its distinctive shape)" of the tsuginoma (additional room) were finished in black lacquer. Damaged areas were refinished and their original beauty restored.
